# GARDEN TRACTORS

## A Perfect Fit: 1982 Case 222

*Ray Hoffman's interview with Les Currie*

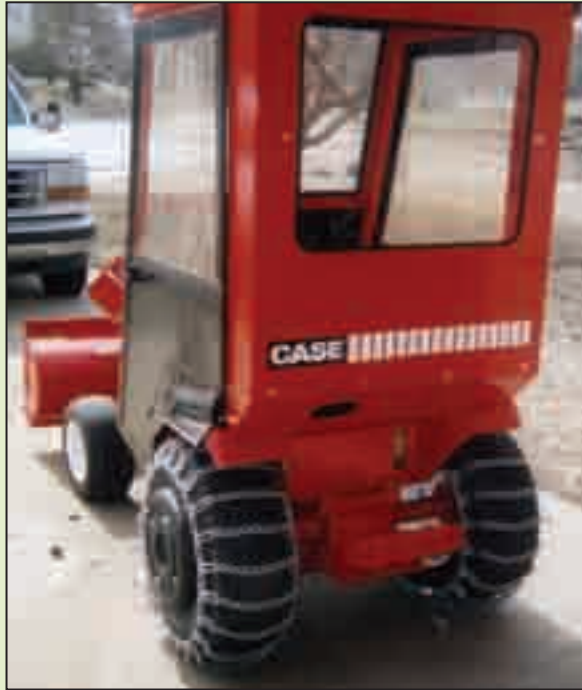
The 12hp Kohler engine had a noticeable knock, so I found a new K301 AS short block at the Tulsa Engine Warehouse for \$650. After new fluids were put in the hydraulics, the drive system and attachment lift cylinder worked perfectly. I had to install a new rubber insert in the Lovejoy flex coupling between the motor and

hydraulic pump. A pair of new front tires finished the restoration, and I purchased a set of new 23x8.50/12 tire chains from a site on the internet.
